RED RIVER WATERSHED

GILLHAM LAKE

COSSATOT RIVER, ARKANSAS

EMBANKMENT CRITERIA AND PERFORMANCE REPORT

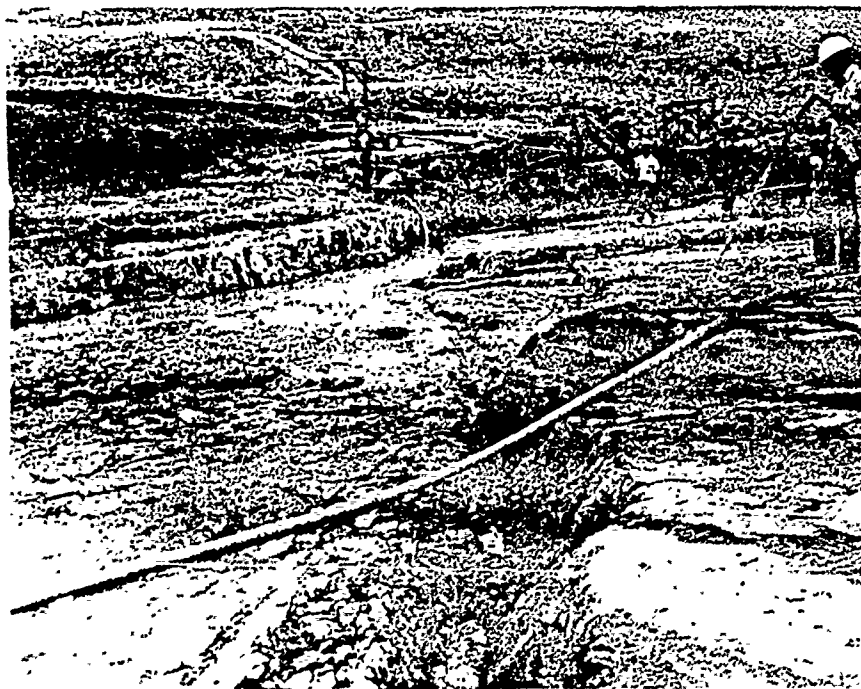
Photo. No. 10

View SW along a minor fault which crosses centerline at approx. Sta 28+40.
